TCEQ Interoffice Memorandum

Date: September 12, 2017
Subject: TX03770 – Forest Lake Dam

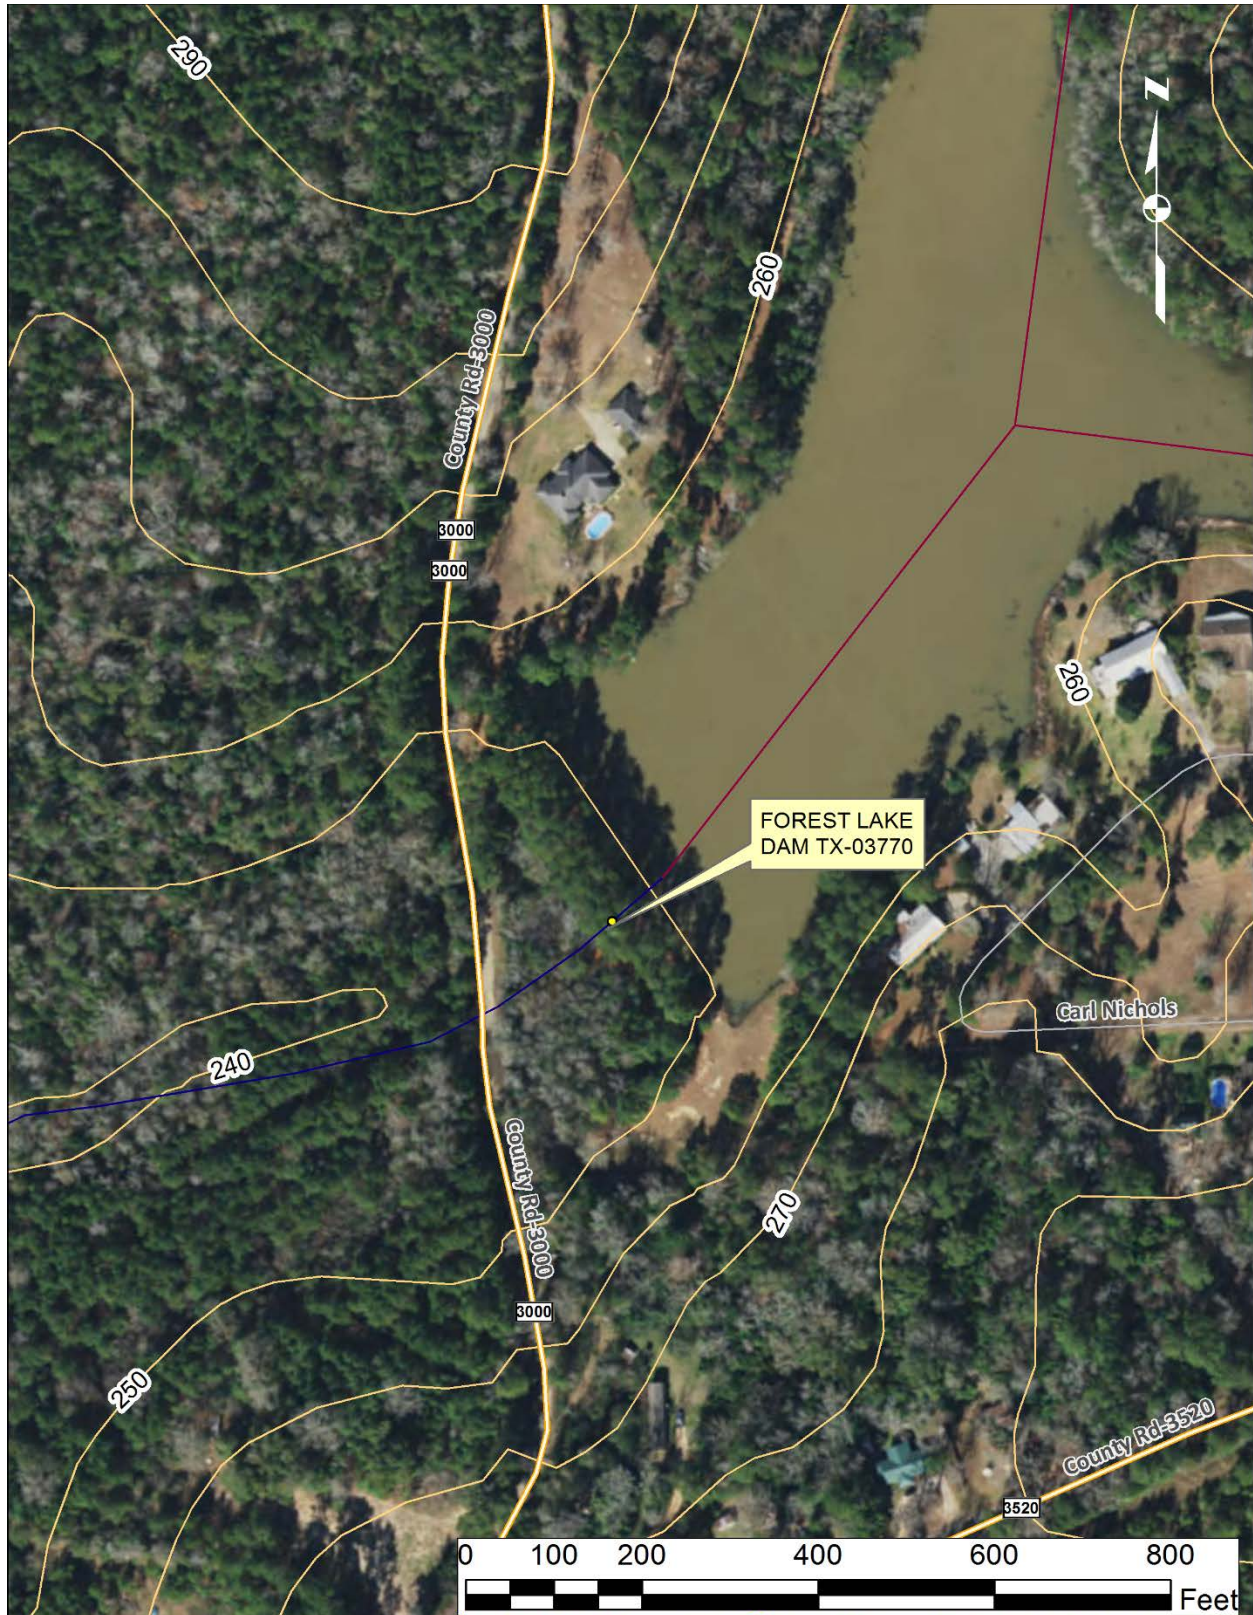
Figure 1–Aerial View (2016)
Forest Lake Dam - 10' Contours

The following observations were noted as shown in the attached figure and photos: The breach was located at the left end of the dam (service spillway location) estimated at 30-Ft wide by 15-Ft high (**See Photos 1-10**). Portions of the drop-inlet spillway (48-in HDPE pipe) were carried downstream. The lake level was observed to be lowered to the approximate elevation of the bottom of the drop inlet. Large amounts of sediment were noted at the toe of the embankment and at the roadway and culvert approximately 100-Ft downstream of the dam.
